# Portage Creek Sediment Remediation Project Kalamazoo, Michigan

## Pre-Sediment Removal Structure Feature Assessment Removal Areas SA3-A, SA3-B and SA3-Access

F&V Project Number: 809930  
August, 2012

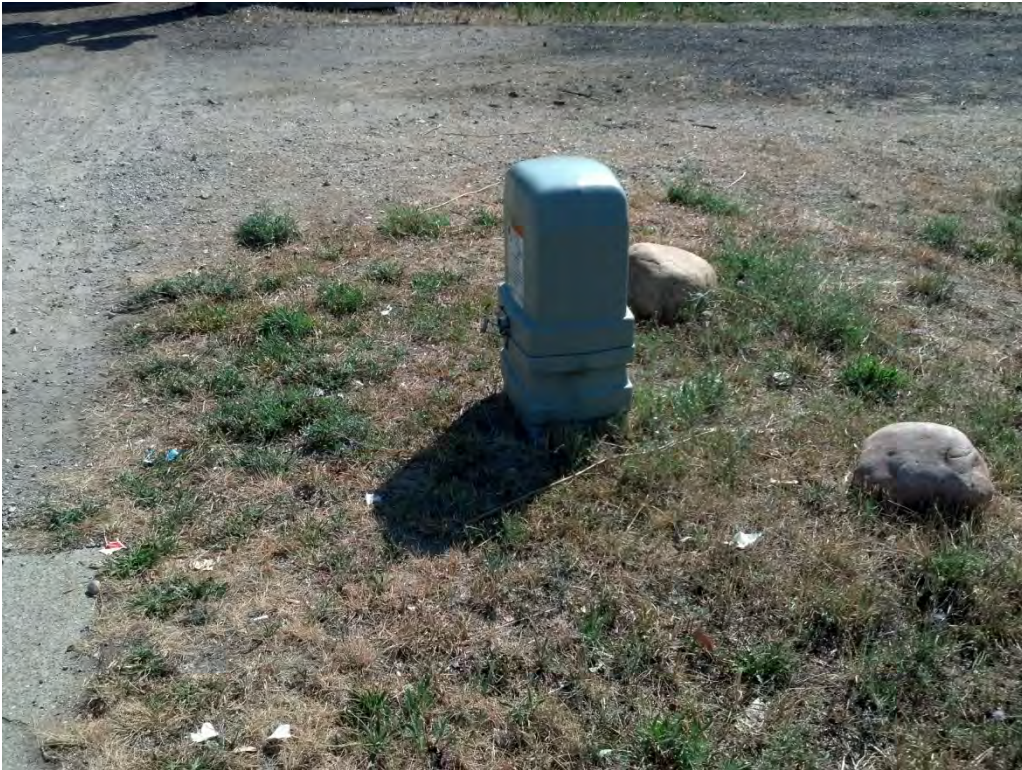
- The pedestal appears to be in good condition.

View of the pedestal looking east

- The pedestal should be identified/protected with construction fencing or similar during the work.

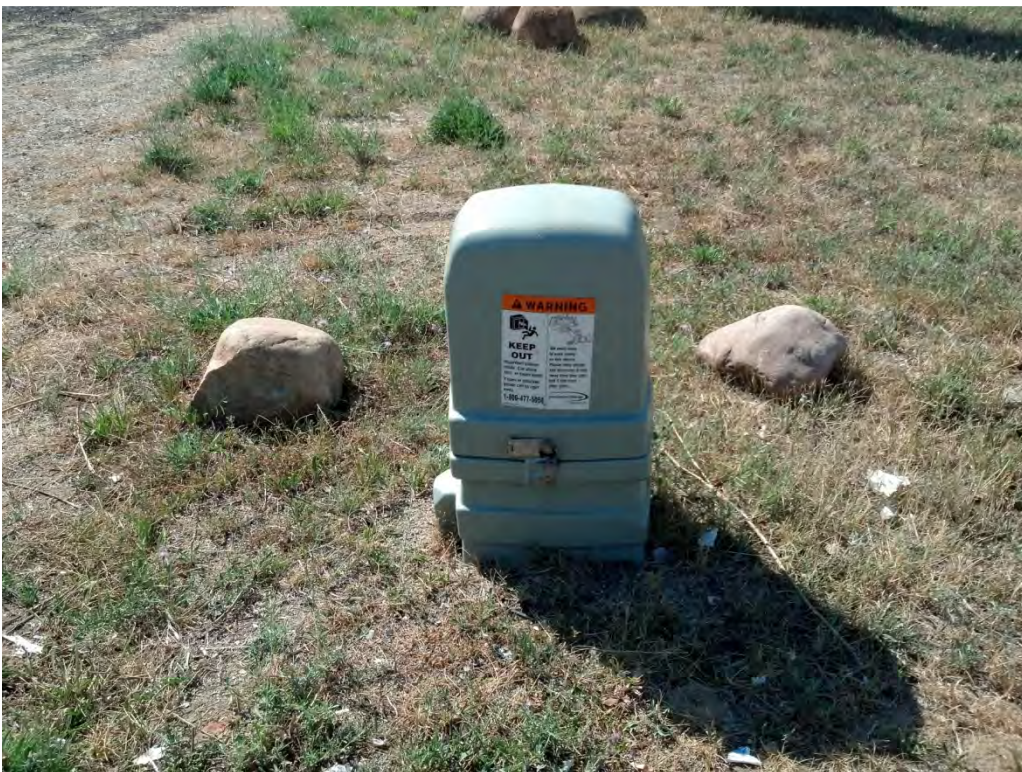
View of the pedestal looking south

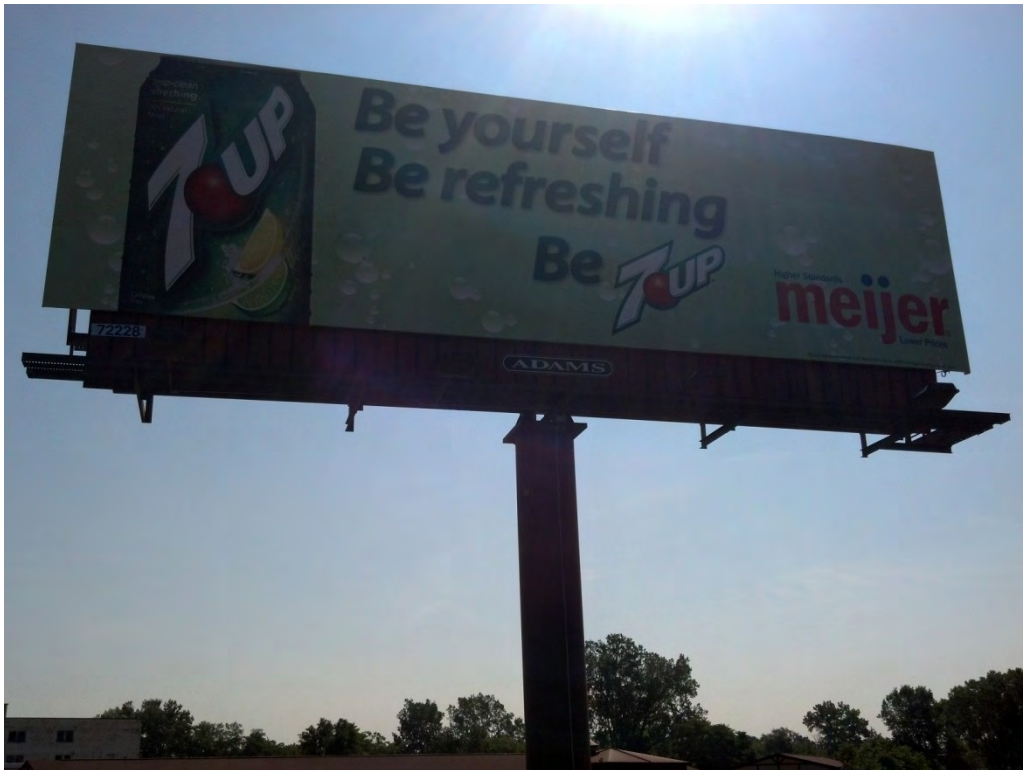
- The steel column has minor scrapes and flaking paint.
- There is an electric service panel on the west side mounted on a timber panel. One of the box covers is loose.
- The electric conduit extending to the southwest is loose.
- The grounding rod is exposed and loose.
- The exposed concrete pedestal has hairline cracking and isolated spalling.

View of billboard looking east

- The billboard structure should be identified/protected with construction fencing or similar during the work.

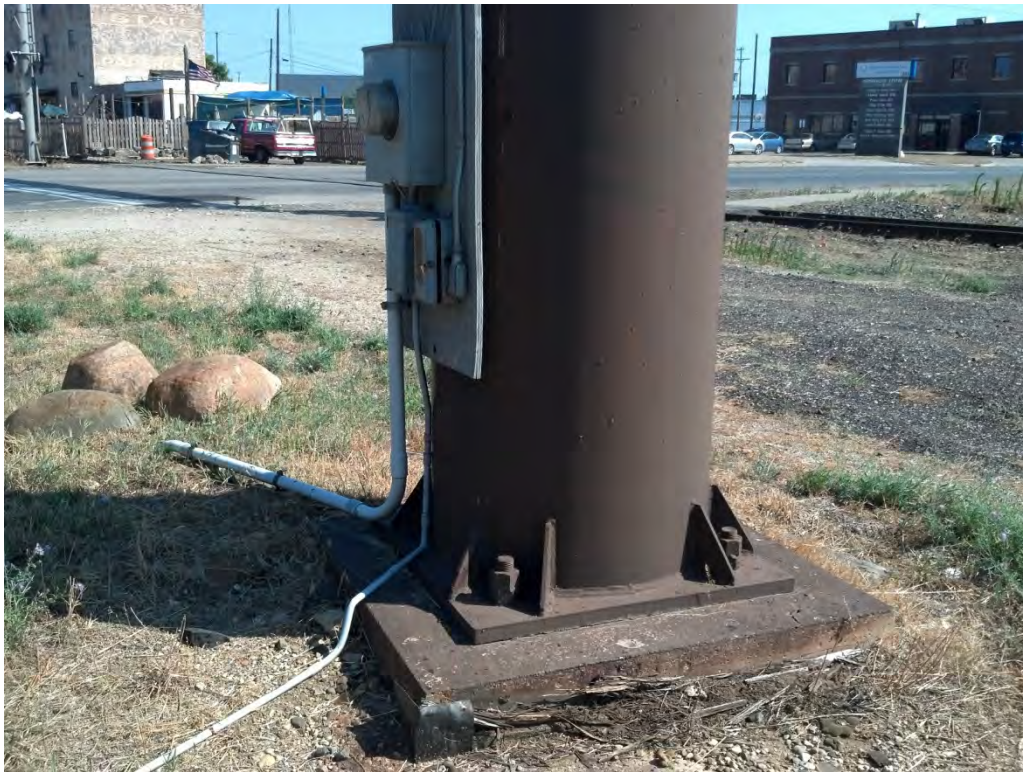
View of billboard foundation looking northeast

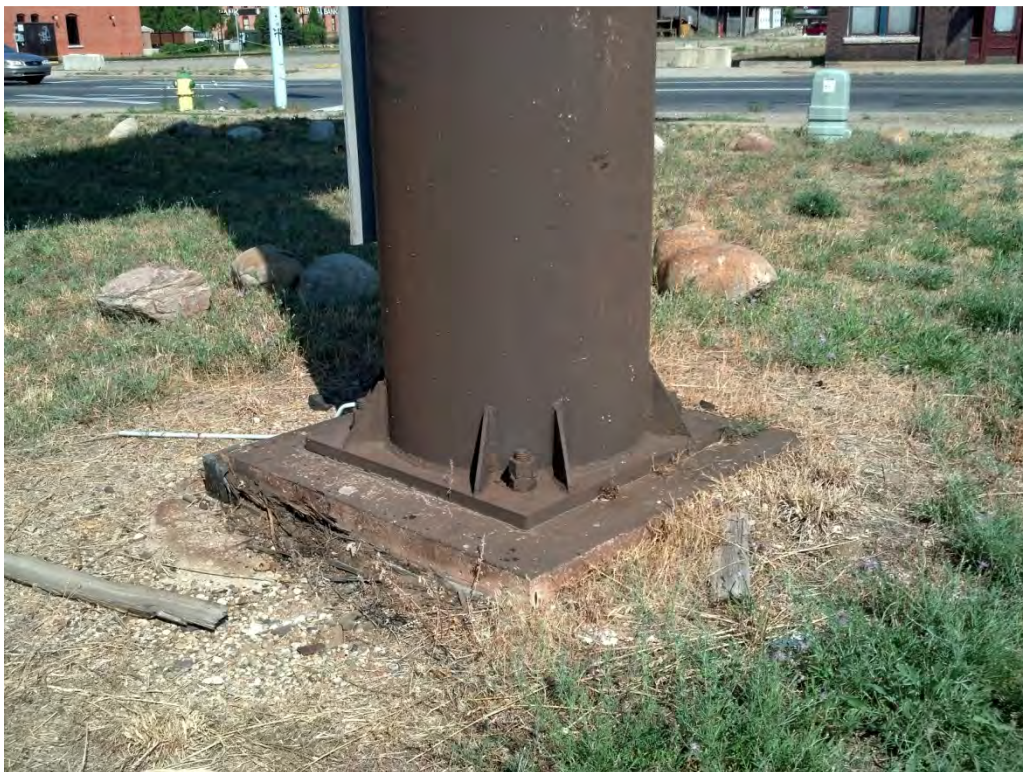
View of billboard foundation looking north

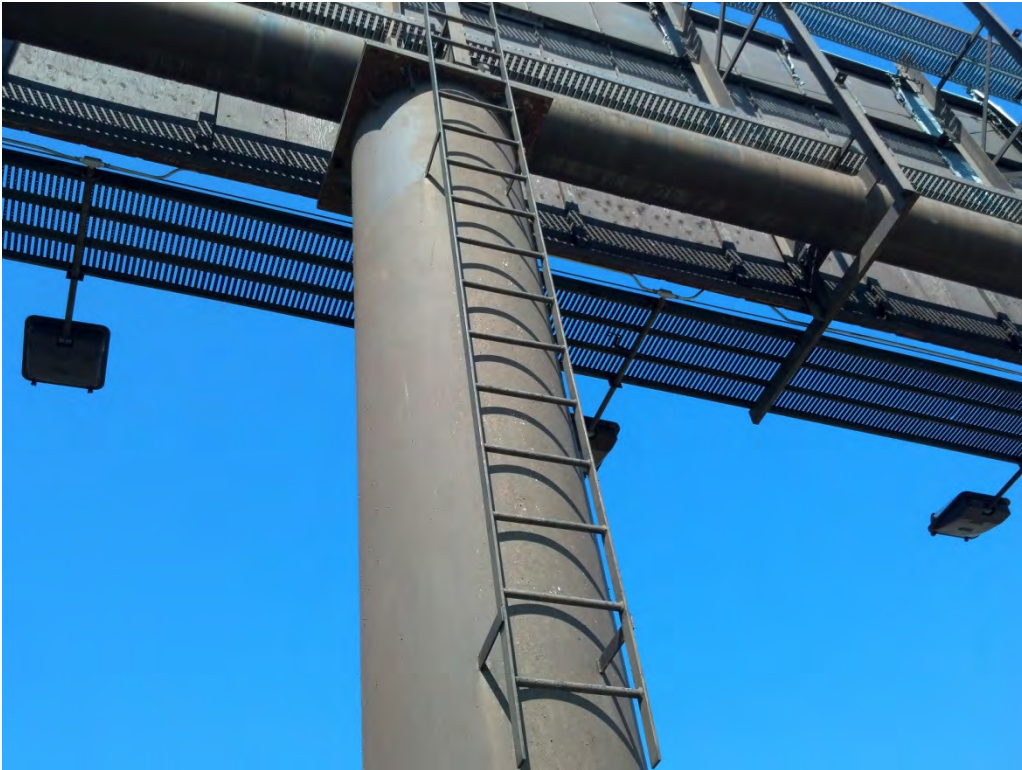
Ladder on east side of column

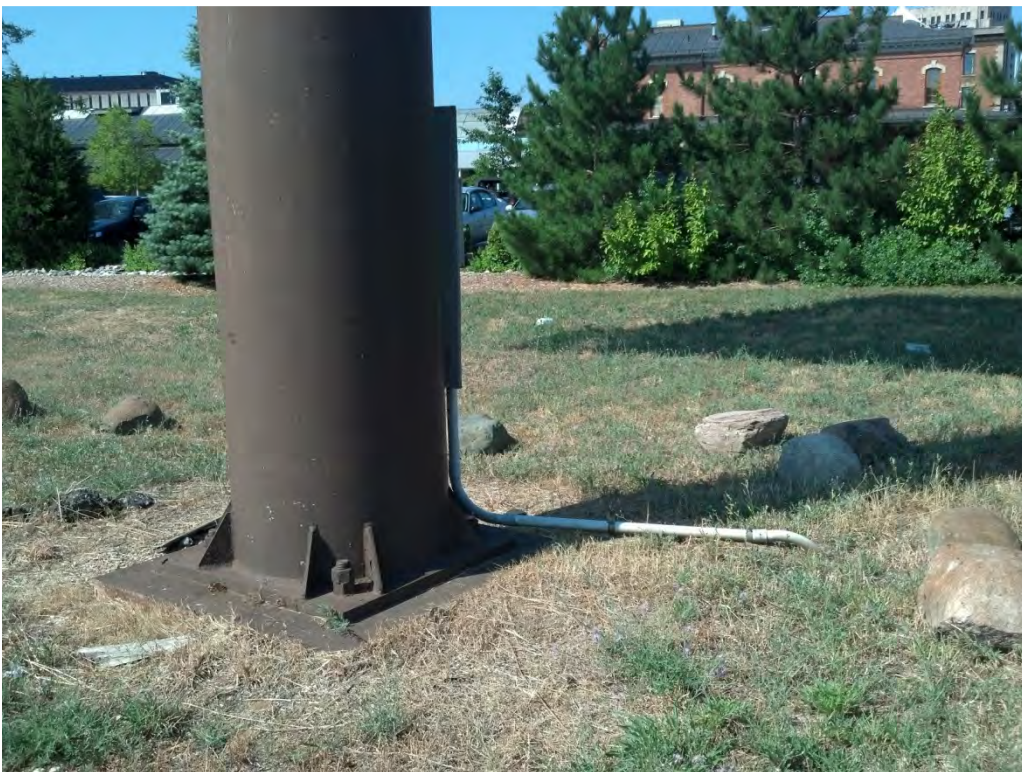
View of billboard foundation looking southwest

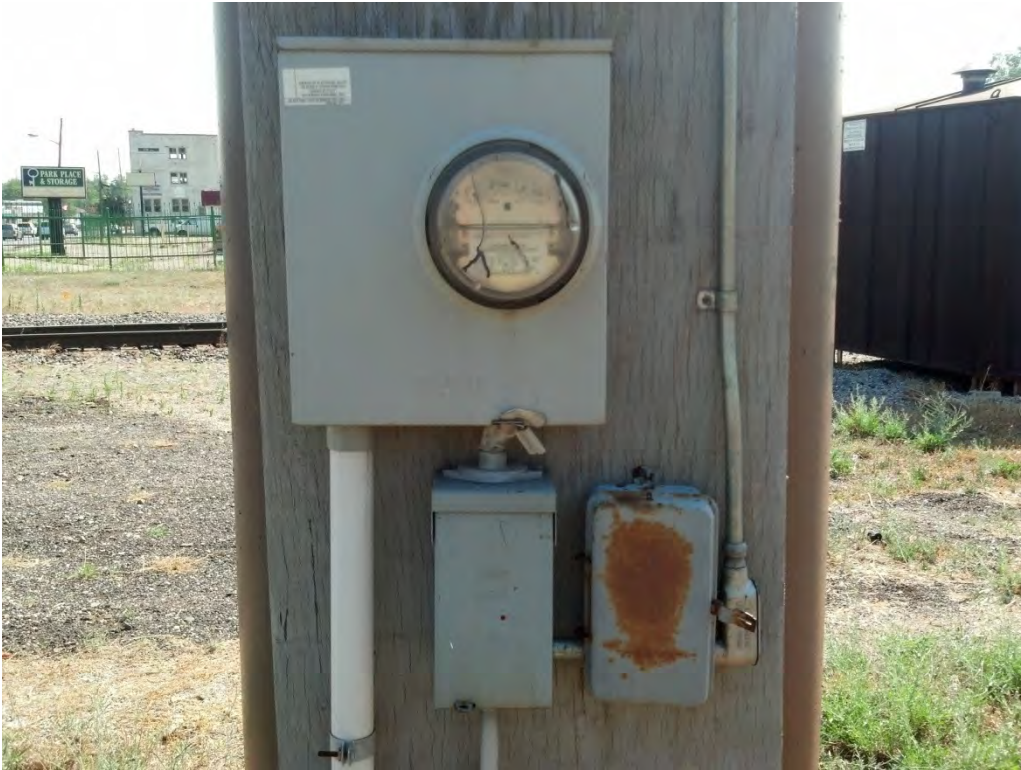
Close-up view of service panel

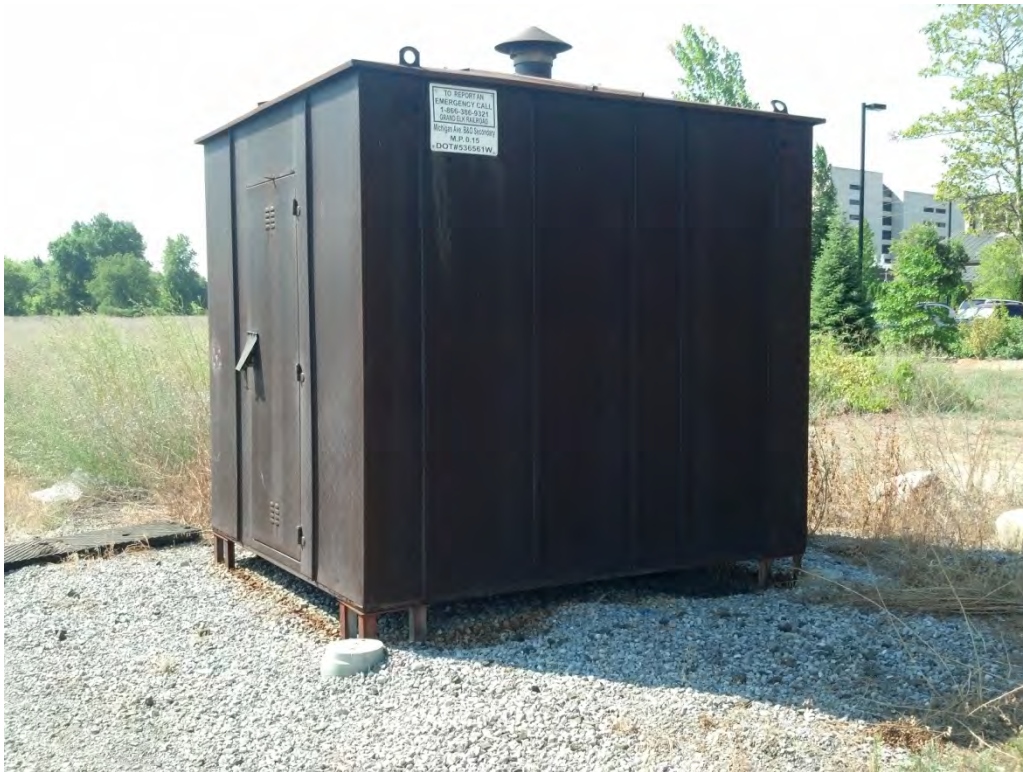
- The siding has moderate to severe surface corrosion.
- There is a sink hole under the northwest corner.
- There is an electric service panel on the west wall.

View of shed looking southwest

- The shed structure should be identified/protected with construction fencing or similar during the work.

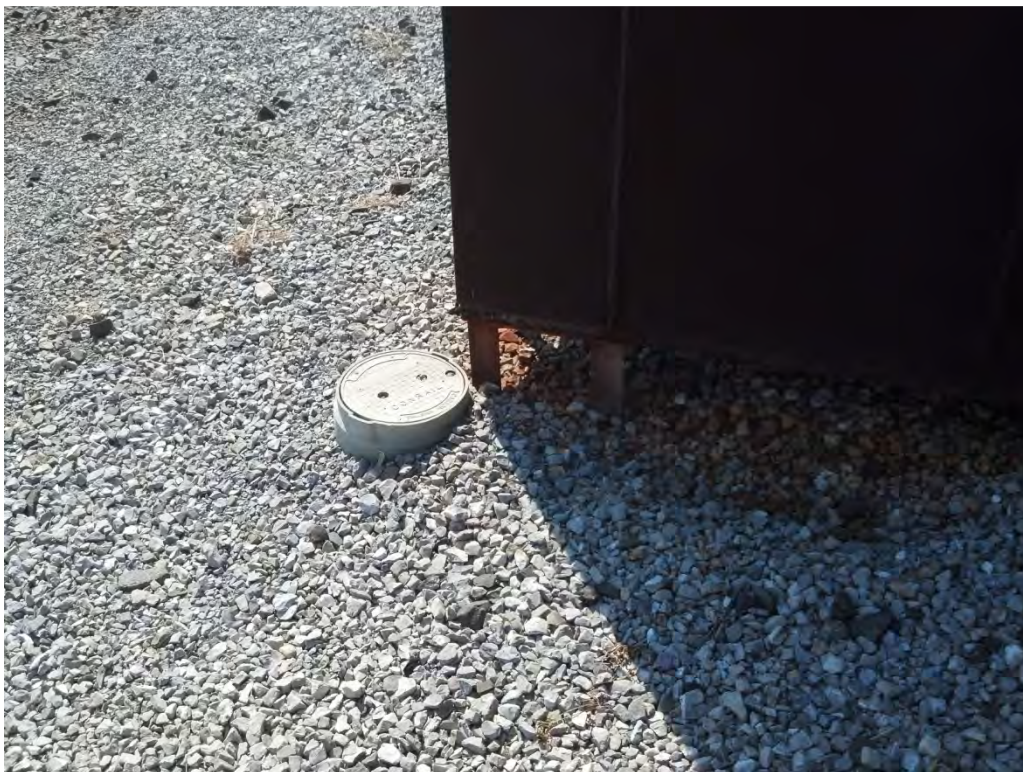
Utility access at corner of shed

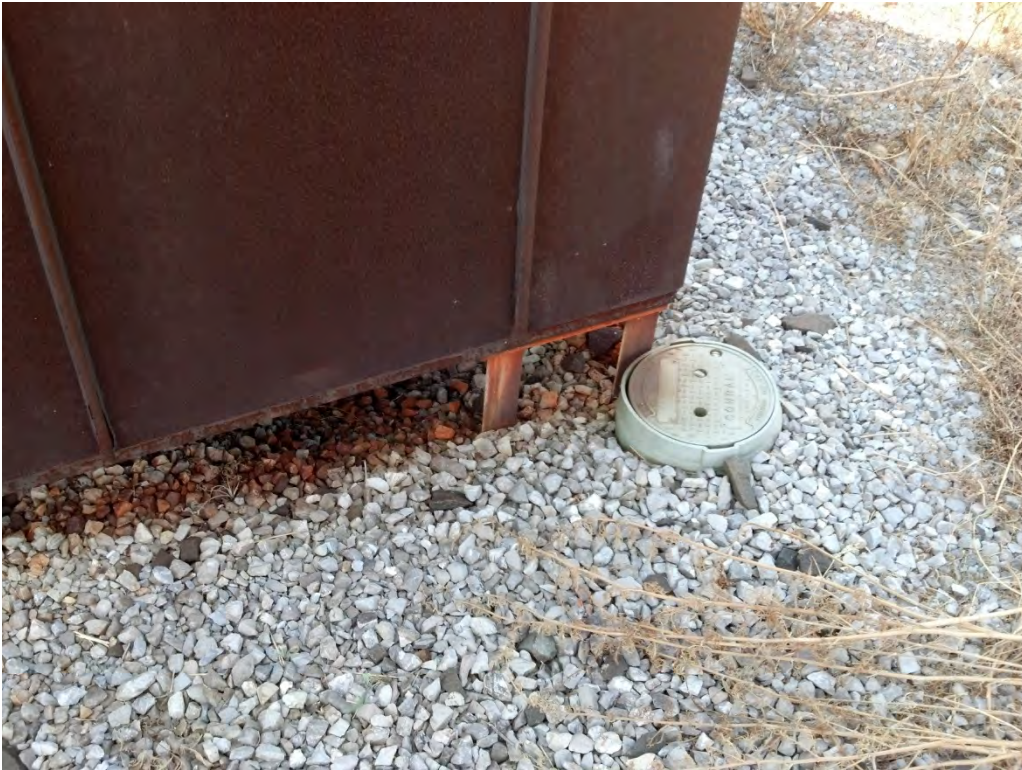
Utility access at corner of shed

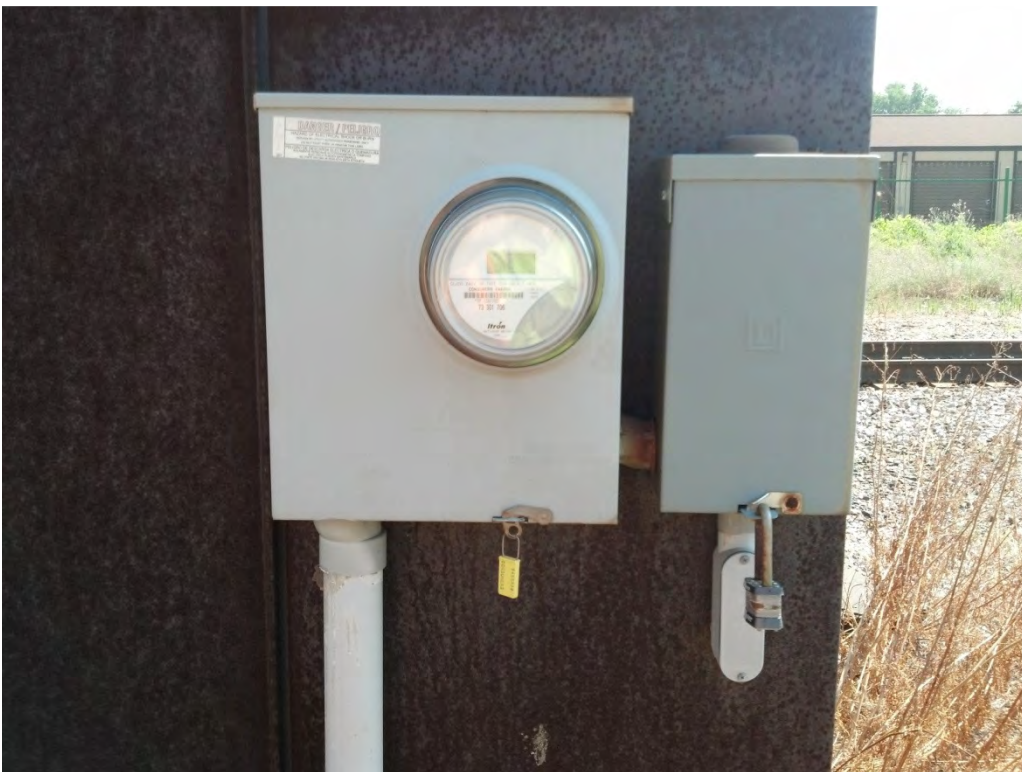
Electric panel on side of shed

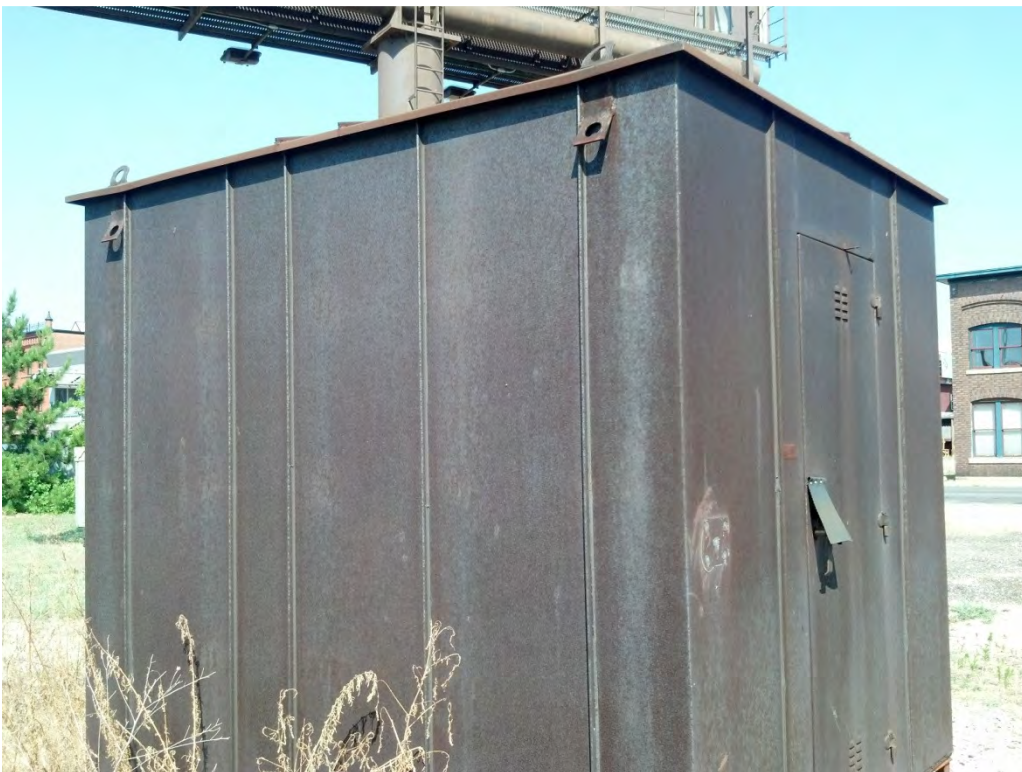
View of shed looking northwest

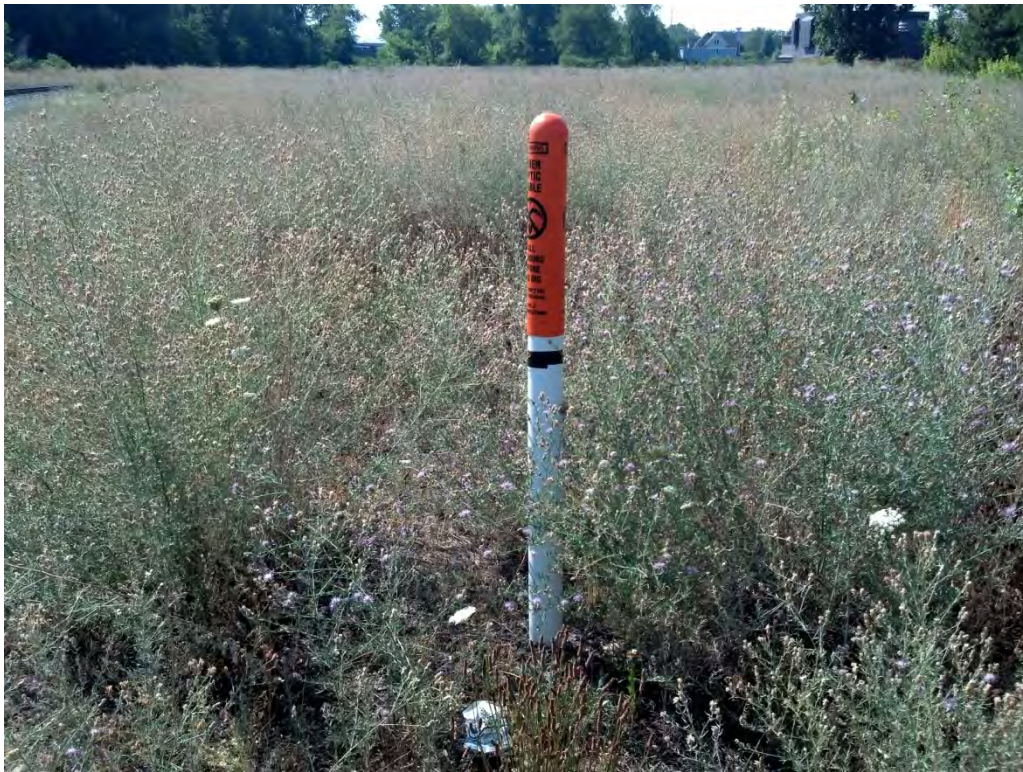
- The marker post appears to be in good condition.

View of marker post looking south

- The marker post should be identified/protected with construction fencing or similar during the work.

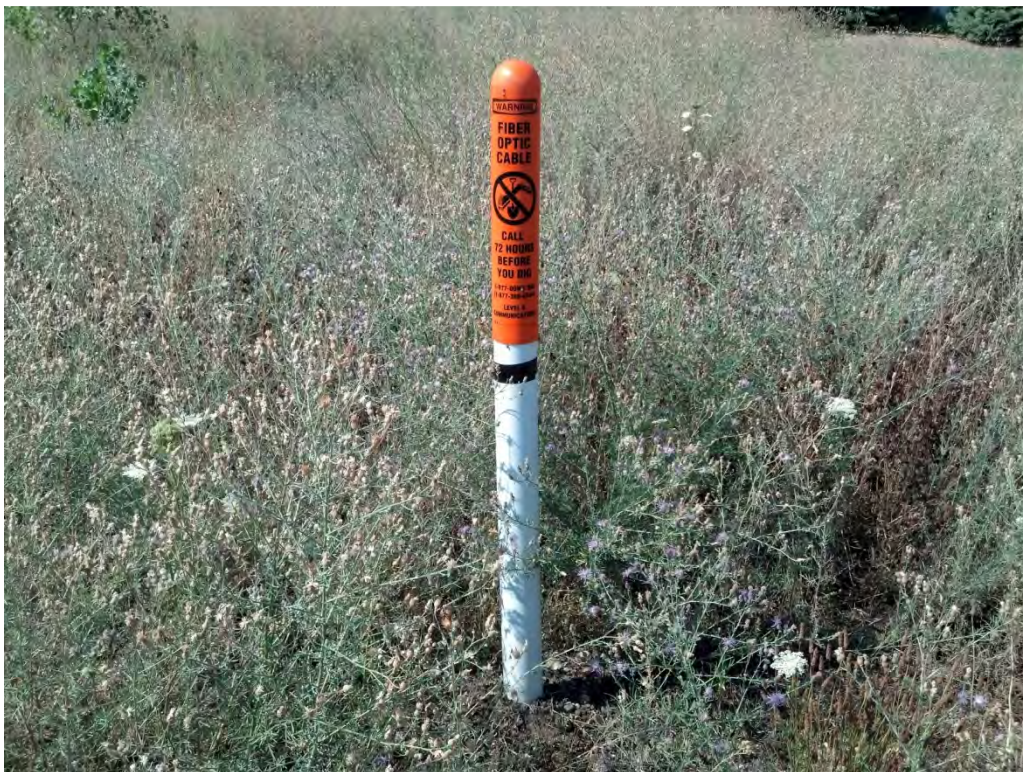
View of marker post looking west
